Manhole Inspection Summary

Manhole # S27S1_003MH

Location Address: **810 W. Potapsco Ave.**

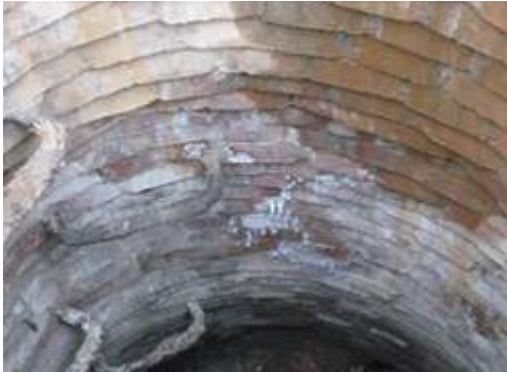
Infiltration

Infiltration: ☐ None ☐ Joint ☐ Cracks ☐ Mortar ☐ Roots ☒ **Wall**

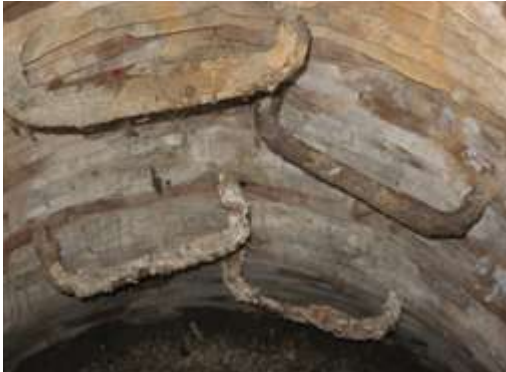
Steps Count: **4** Missing: **0** ☒ **Corroded**

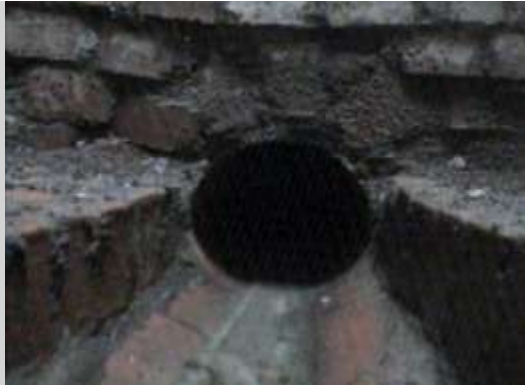
12 O'Clock Outflow

8 in. Circular Gravity Sewer
Pipe Out @ 12 O'Clock

Pipe Height: **8.4** (in.) Rod and Bar (Angled)
Pipe Material: **Clay** ☐ Pipe Lined
Invert Depth: **9.20** (ft.) Flow Characteristics: **Slow**
Deposits: ☒ None ☐ Mud ☐ Sludge ☐ Debris ☐ Grease
Silt Depth: (in.) Deposits Extent:
Infiltration: **None** Pipe Seal Cond: **Sound**

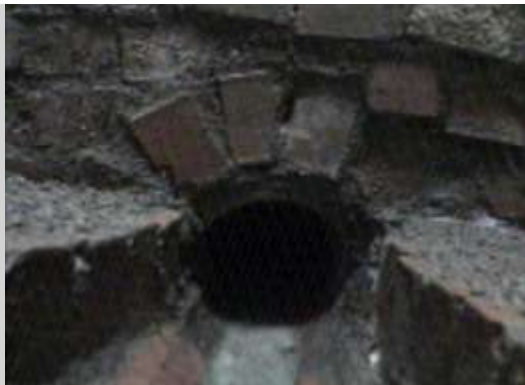
5 O'Clock Inflow

6 in. Circular Service Sewer
Pipe In @ 5 O'Clock

Pipe Height: **7.2** (in.) Rod and Bar (Angled)
Pipe Material: **Clay** ☐ Pipe Lined
Invert Depth: **8.80** (ft.) Flow Characteristics: **Slow**
Deposits: ☒ None ☐ Mud ☐ Sludge ☐ Debris ☐ Grease
Silt Depth: (in.) Deposits Extent:
Infiltration: **None** Pipe Seal Cond: **Sound**
